# Manhole Inspection Summary

Manhole # S51A\_\_025MH

Insp Date: **5/6/08 10:51 AM**

**Location** Address: **rear 439 n linwood ave**

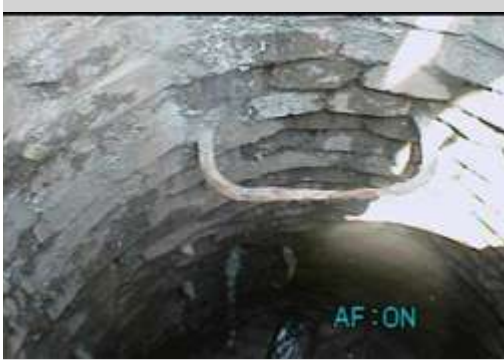
Defect 1

**Steps** Count: **4** Missing: **3** ☒ **Corroded**

steps

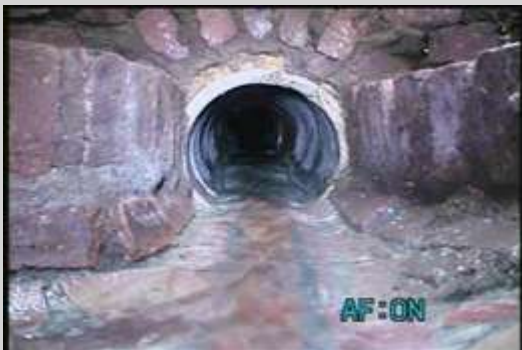
12 O'Clock Outflow

8 in. Circular Gravity Sewer  
Pipe Out @ 12 O'Clock

Pipe Material: **Clay** ☐ Pipe Lined

Invert Depth: 8.02 (ft.) Flow Characteristics: **Fast**

Infiltration: **None** Pipe Seal Cond: **Unknown**

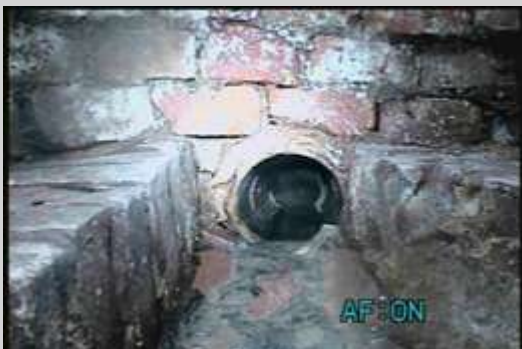
4 O'Clock Inflow

6 in. Circular Gravity Sewer  
Pipe In @ 4 O'Clock

Pipe Material: **Clay** ☐ Pipe Lined

Invert Depth: 7.36 (ft.) Flow Characteristics: **Fast**

Infiltration: **None** Pipe Seal Cond: **Unknown**

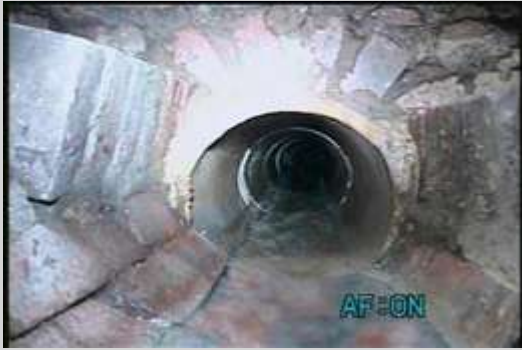
6 O'Clock Inflow

8 in. Circular Gravity Sewer

Pipe In @ 6 O'Clock

Pipe Material: **Clay** ☐ Pipe Lined

Invert Depth: **7.77** (ft.) Flow Characteristics: **Fast**

Infiltration: **None** Pipe Seal Cond: **Unknown**

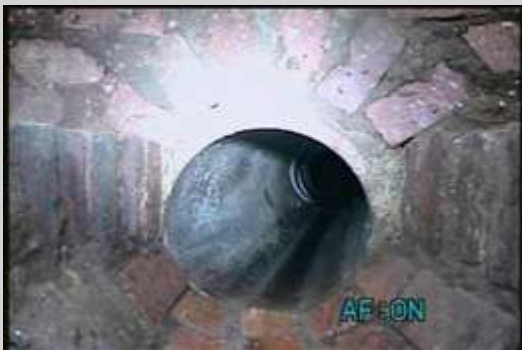
9 O'Clock Inflow

8 in. Circular Gravity Sewer

Pipe In @ 9 O'Clock

Pipe Material: **Clay** ☐ Pipe Lined

Invert Depth: **8.00** (ft.) Flow Characteristics: **Fast**

Infiltration: **None** Pipe Seal Cond: **Unknown**
